ANNUAL REPORT

CALENDAR YEAR 2010

**UPPER FOX RIVER WATERSHED COMMUNITIES GROUP MUNICIPAL
STORMWATER DISCHARGE PERMIT
WPDES PERMIT NO. WI-S050105-2**

March 2011

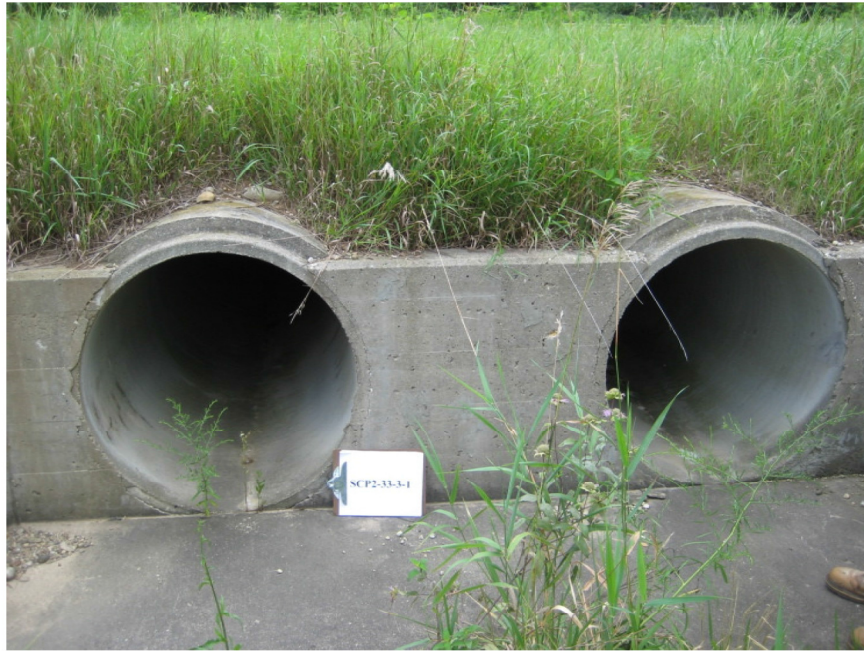
SCP2-33-3-1 W

Outfall ID	SCP2-33-3-1
Date of Last Rainfall	7/24/10 => .86"
Date Inspection Performed	7/28/10
Name of Inspector	BGH DRR
Receiving Water	Scuppernong Creek
M.H. or Outfall (Circle One)	M.H. <u>Outfall</u>
Pipe Size	DUAL 36"
Pipe Material (Circle One)	<input checked="" type="radio"/> RCP CMP PVC HDPE Steel DI VCP Other
Color (Circle One)	Clear Yellow Gray Orange Brown Green Red Other
Turbidity (Circle One)	Clear Slightly Cloudy Cloudy Opaque
Surface Sheen (Circle One)	None Oil Gasoline Scum Unknown
Odor (Circle One)	None Oil Decaying Vegetation SO ₂ Fuel Sewage Methane Unknown
Pipe Active (Circle One)	<input checked="" type="radio"/> No Trickle Moderate Substantial

SCP2-33-3-1	Scuppernong Creek	RCP	Dual 36" Circle	No	NO	
SCP2-33-4-1	Scuppernong Creek	CMP	52" x 36" Ellipse	No	NO	Clear vegetation from east invert
