ANNUAL REPORT

CALENDAR YEAR 2012

**UPPER FOX RIVER WATERSHED COMMUNITIES GROUP MUNICIPAL
STORMWATER DISCHARGE PERMIT
WPDES PERMIT NO. WI-S050105-2**

March 2013

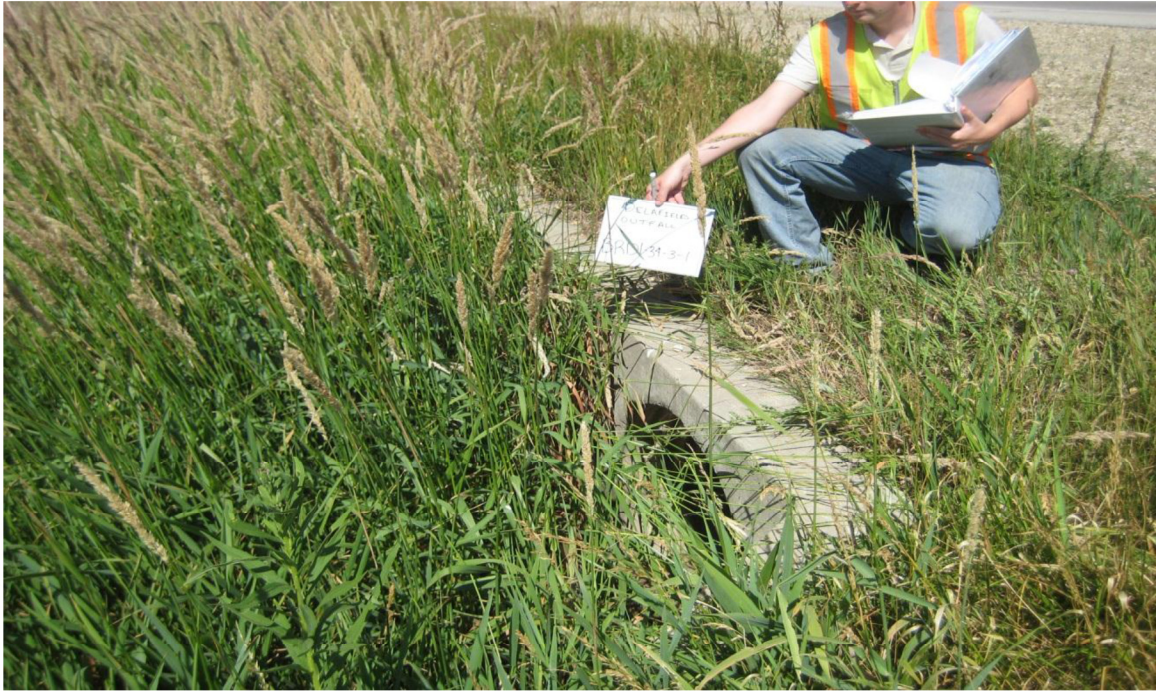
BRD1-34-3-1 – South Invert

NOTES
No Water Present

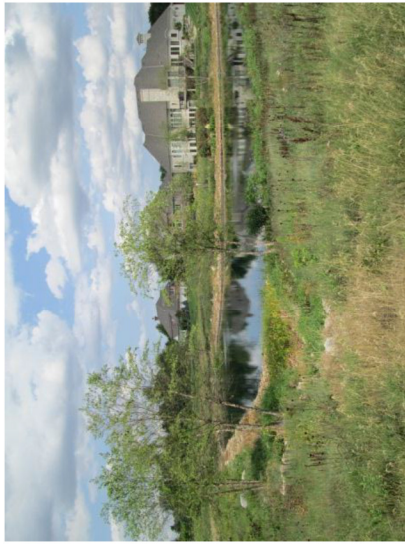
Overall BMP 25

Assessment	Code	Comments
Visible pollution / muddiness	NP	
Sediment / debris accumulation	N/A	TO BE DETERMINED LATER
Plants are dead, diseased, or dying	NP	
Vegetation length (too short/too long)	NP	
Bare soil / erosive gullies	M	BARE SOIL VISIBLE DUE TO LOW WATER LEVEL
Algae cover (estimate %)	0	
Invasive vegetation (estimate %)	0	
Other

Assessment	Code	Comments
Erosion and/or loss of dam material	NP	
Shrubs / trees present	M	A FEW TREES ARE PRESENT
Animal burrows	NP	
Soft spots or boggy areas	NP	
Other

- WATER FLOWS INTO POND BY ONE ROCK LINED SWALE AND TWO RCP CULVERTS. WATER EXITS THE POND VIA AN OUTLET STRUCTURE WHICH DISCHARGES THE WATER TO THE SOUTH.
- WATER LEVEL IN POND IS LOW DUE TO LACK OF RAIN.

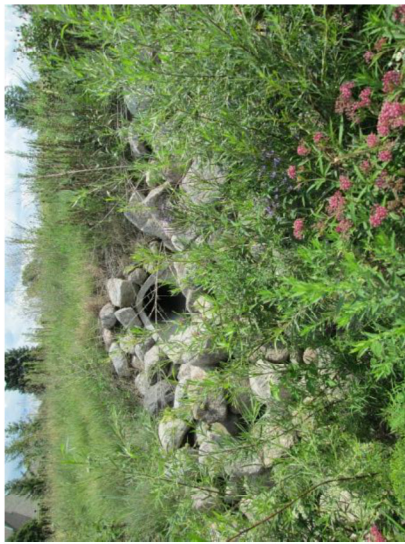
Inlet Pipe BMP 25

Assessment	Code	Comments
Obstruction: vegetation/debris/sediment	NP	
Erosion/undercutting	NP	
Displacement of fabric/rip rap	NP	
Pipe Condition	NP	
Other

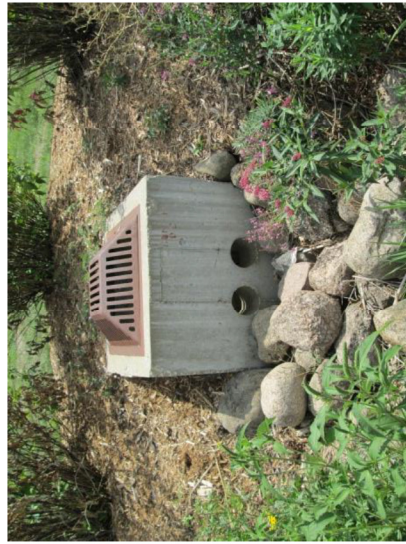
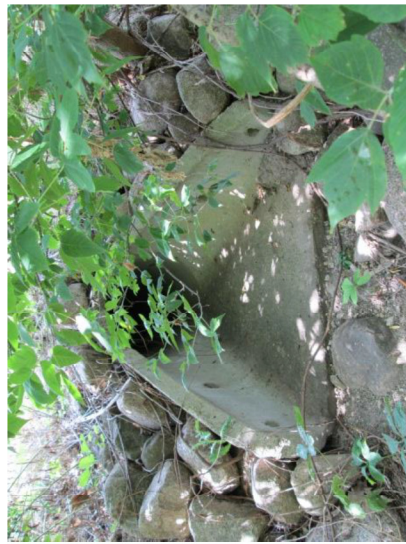
Outlet BMP 25

Assessment	Code	Comments
Obstruction: vegetation / debris / sediment	NP	
Erosion/undercutting	NP	
Joint failure / loss of joint material	NP	
Leaking device	NP	
Other
